## 21 Year-old Male Dies when Struck in the Head with a Track Hoe Bucket

**Incident Number:** 02KY106  
**Date of Incident:** November 22, 2002  
**Report Release Date:** June 17, 2003

## **Kentucky Fatality Assessment and Control Evaluation (FACE) Program**

**Subject: 21 Year-old Male Dies when Struck in the Head with a Track Hoe Bucket**

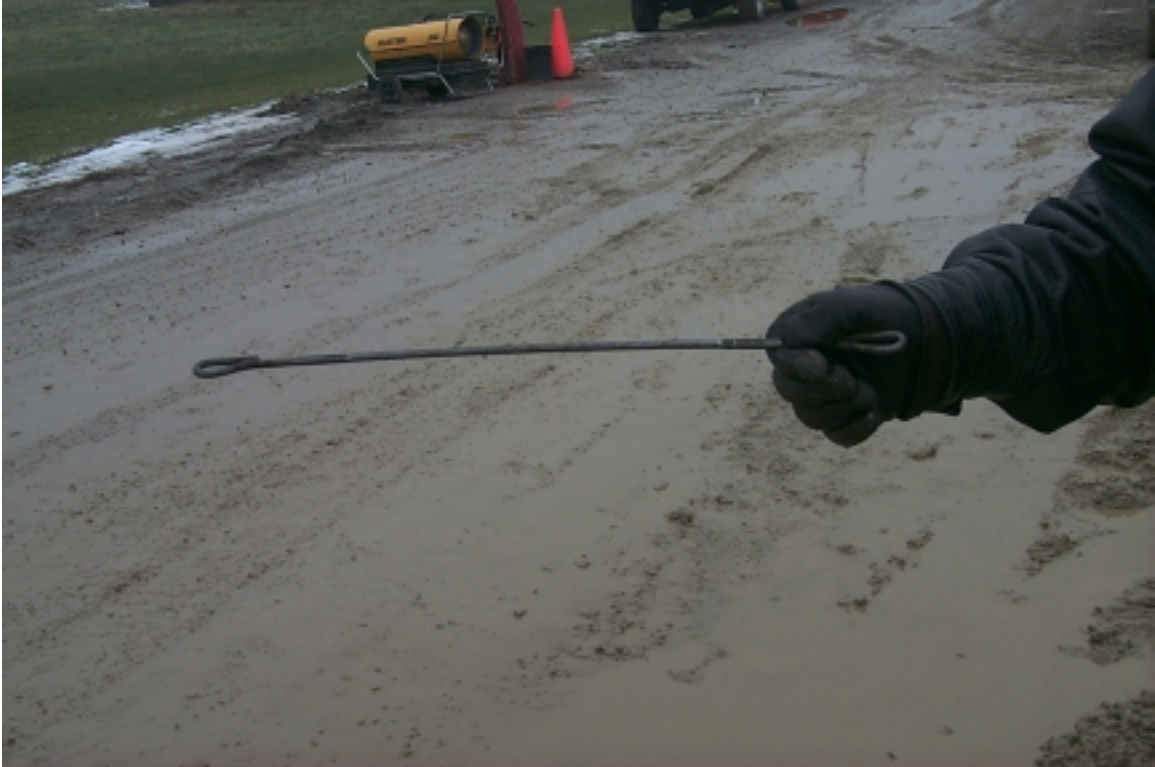
Picture of wire used for horizontal stability of concrete form.

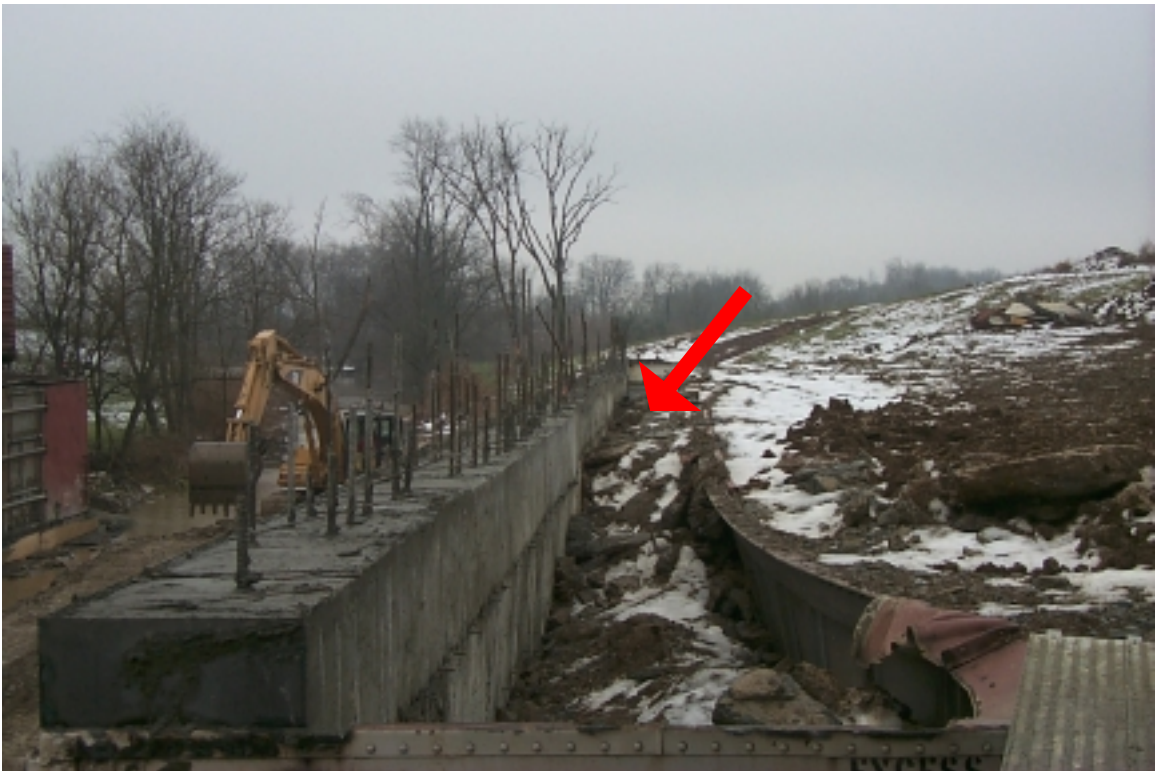
Location where incident occurred. Actual location is at the bottom of this form.

The decedent laborer had been assigned to help build the private airfield. On the afternoon of the incident, the work crew of 6 to 7 employees was pouring a concrete footer when one of the sides of the form collapsed. Three employees were in the path of the flowing concrete. One employee was trapped up to his waist and the other two managed to escape.

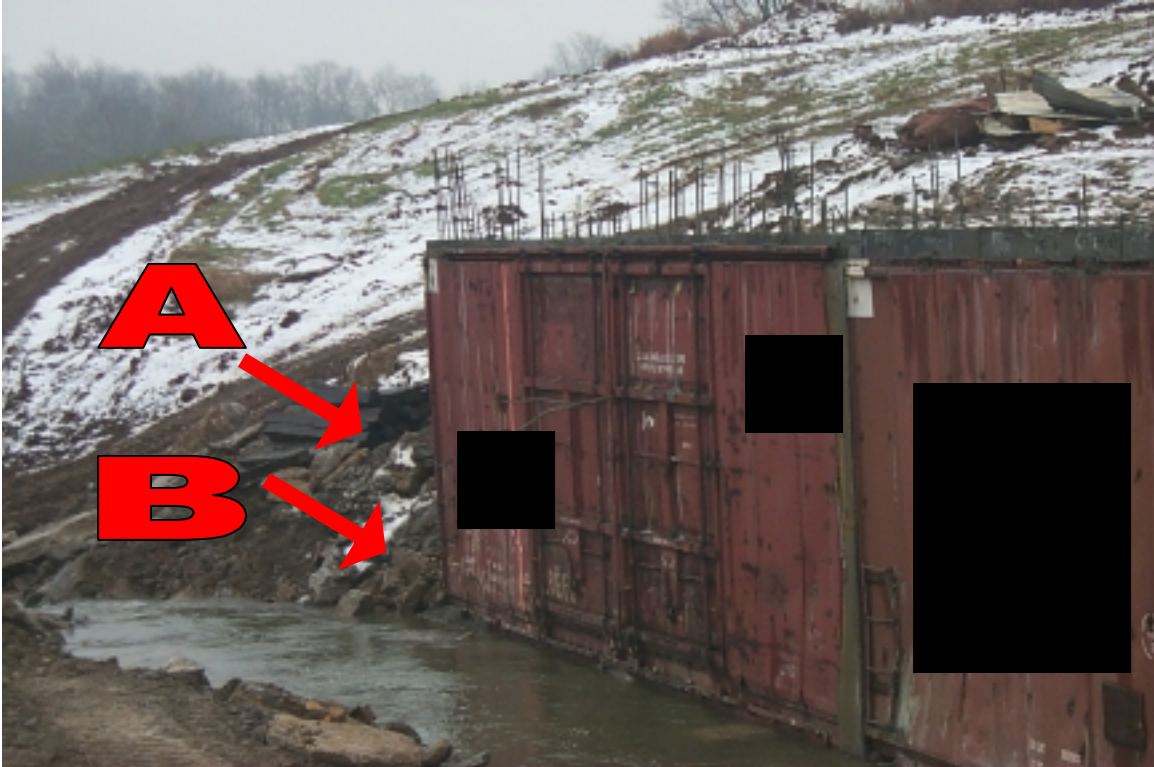
A: Track hoe location at time of incident

B: Location of Decedent at time of incident

**Recommendation No. 1:** A hazard assessment of the work area should be performed every time work conditions change. Workers should not be in a blind spot of heavy equipment operators without the operator's knowledge. When blind spots are identified, a spotter should be used.

A thorough hazard assessment of the job site should be performed whenever conditions change. This would have included taping off the area the track hoe was working in. When working around heavy equipment, an evaluation of potential blind spots should be included in this hazard assessment. Potential blind spots would have been identified and employees not allowed in that area. When workers find themselves in blind spots of equipment operators, there should be a spotter who is in communication with the equipment operator to communicate with the operator while a worker is performing job functions in the operator's blind spot.
